PRECISION AIRMOTIVE LLC Service Information Letter - Fuel Systems

SIL RS-88
SMALL RECIPROCATING ENGINES
RSA-5 and RSA-10
Issued: 6/16/08
Page 1 of 2

SUBJECT: Inspection of Regulator Hex Plug on RSA-5 and RSA-10 Fuel Injection Servos.

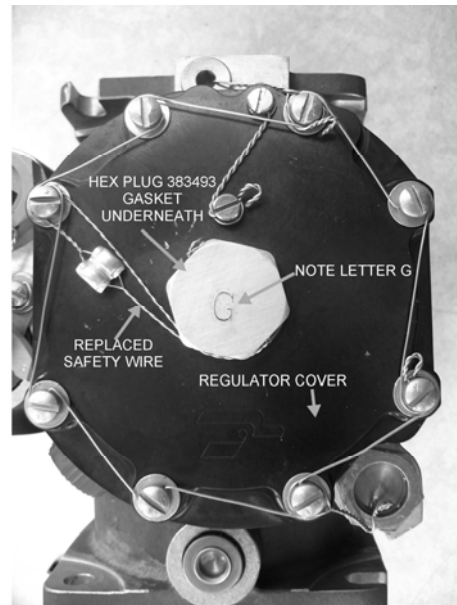
- A. EFFECTIVITY: This Service Information Letter is applicable to all RSA-5 and RSA-10 servos which do NOT have a “G” marked on the regulator hex plug (see photograph page 2.).

- C. DETAILED INSTRUCTIONS: If your aircraft has an RSA-5 or RSA-10 fuel injection servo that is NOT marked with a “G” on the regulator hex plug, during each annual or other periodic inspection (but at least annually) the regulator hex plug on the fuel injection servo should be inspected to verify that it is not loose. The regulator hex plug is a 1” brass hex plug on the large round cover on the side of the fuel injection servo. (See photograph page 2.)

6. Stamp or scribe the letter “G” onto the face of the hex plug as shown in the sample photos. This shall be done with the plug removed from the servo. DO NOT stamp the plug with it installed in the servo.

8. The hex plug must be safety wired with .015 thru .025 inch diameter wire to the regulator cover as shown in the photos below. The wire shall pass thru the plug such that it pulls the plug in the tightened direction and does not rest on the corners of the hex on the plug (it is acceptable to wrap under the corners of the hex plug). These photos are just two examples of acceptable safety methods. Other safety wire methods such as those described in FAA AC 43-13-1B (or latest revision) are also acceptable.
